SERVICE INFORMATION

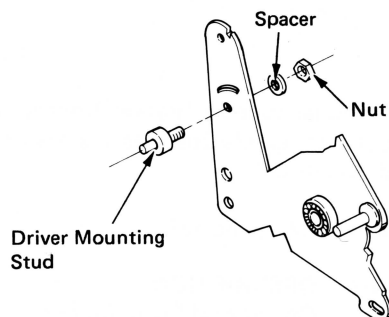
Figure 1

Backspace failures due to a broken driver mounting stud may be corrected using the backspace driver mounting stud B/M.

1. Remove driver mounting stud from backplate by tapping lightly.
2. Remove the "C" clip, washer, driver, pitch cam (disconnect pitch cable), and pitch cam spring from the stud.
3. Insert the new stud (24-155) in the pitch cam spring, pitch cam (connect pitch cable) and driver.
4. Install washer and "C" clip on the front of the stud.
5. Install stud through the hole in the backplate and secure with washer and nut (Figure 1).

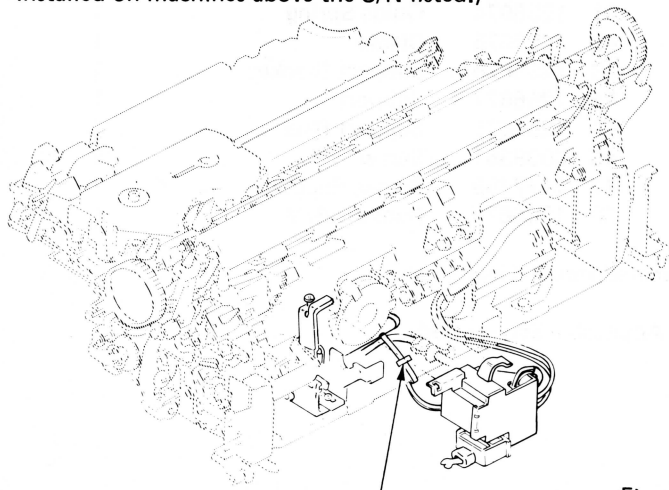
Figure 1

PRECAUTION: The motor shell could become live (i.e.,
line voltage present on the motor shell) on dual pitch
"Selectric" IIIs manufactured prior to the S/Ns listed below.
The length of the line cord from the white strain relief to the
transformer may be excessive. The added length can allow the
cord to contact the motor pulley/shaft. This may wear the line
cord insulation, resulting in the shell becoming live.

1. Unplug the line cord and remove the covers.
2. Check for damage to the line cord insulation in the area
indicated and replace it if damage is evident.
3. Install wire tie (11-606) as shown in Figure 1.
4. Reapply power and check for proper machine operation.

NOTE: All machines within the specified S/N range must be
checked for this condition on the next service call. The wire
tie must be installed on **ALL** machines. (The wire tie is plant
installed on machines above the S/N listed.)

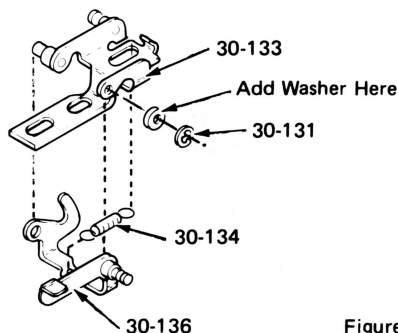
Figure 1

If experiencing problems in lifting the top cover (30-151) on sound machines, check for excessive side-to-side motion of the hood latch on the RH hood bracket (30-133). The top cover latch (30-136) may have slipped off the RH side of the bracket (30-133) and jammed the cover. Washer (P/N 1091220) has been used in the plant to eliminate the problem and can be used if needed in the field. Install washer as shown in Figure 1.

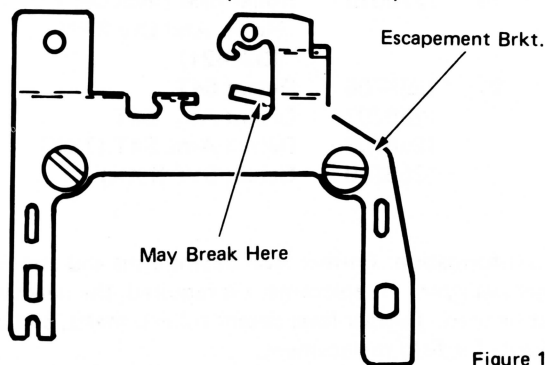
Figure 1

Some machines within the specified S/N range were manufactured with improperly heat treated escapement brackets (07-1).

If this condition occurs replace the escapement bracket.

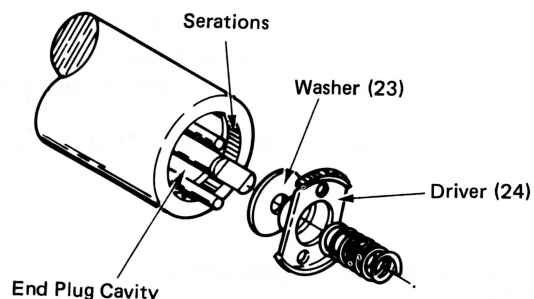
Figure 1

Some machines were manufactured with the potential of preventing the platen driver from fully engaging the platen. This may be caused by either an interference between the cavity in the platen end plug and the washer (12-23) — fig. 1, or small pieces of plastic end plug material that may become lodged between the driver (12-24) and the end plug serrations. If experiencing this condition, clean out the platen end plug and replace the existing washer with the current smaller diameter washer PN1359915.

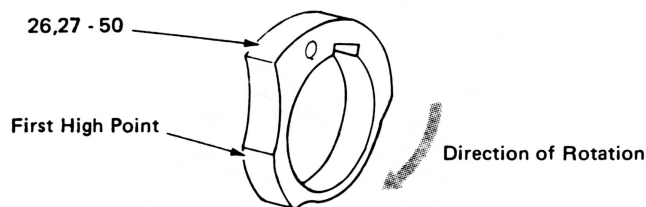
Figure 1

Some machines were manufactured with a defective correction tape feed cam (26, 17-50) which is slightly undersized on the first high point. This condition can be observed by slowly hand cycling the correction mechanism while checking the amount of correction tape feed. The tape should feed one-third before print and two-thirds after print. Machines failing to pull enough tape during the initial feed operation will have random correction failures.

Defective correction feed cams can be replaced without removing the ribbon plate assembly.

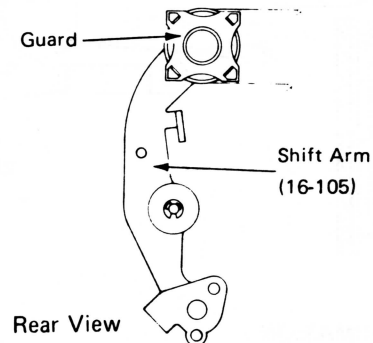
Figure 1

To reduce repeated rotate tape replacement caused by the tape becoming disengaged from the shift arm pulley, the Mag Card velocity tape guard (25-34; P/N 1457036). may be installed. Prior to installing the guard, ensure that a machine malfunction is not causing the tape problem. Install the guard as shown in figure 1.

NOTE: Due to a tolerance build-up of the related parts (shift pulley, rotate tape and velocity guard), a binding condition may occur on some machines. Reducing the length of the velocity guard tips by sanding, filing, etc., will reduce the binding condition.

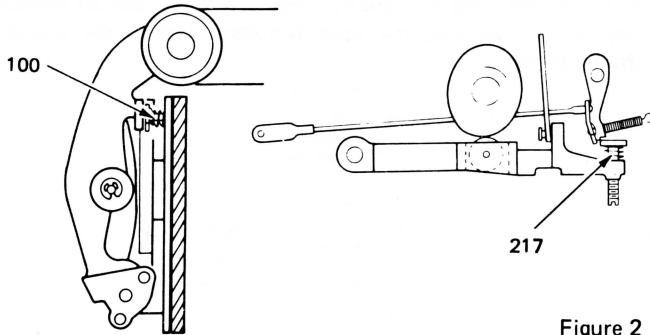
Figure 2

Compression springs were also designed to replace the shift arm stop screw lock nut (16-100) and the negative bail adjusting screw lock nut (23-217, Fig 2). However, due to manufacturing problems, the use of the compression springs has been discontinued.

A limited number of machines have reached the field with compression springs that may allow the stop screw(s) to move. If experiencing problems with varying selection adjustments, install the appropriate lock nut (16-100) or (23-217) to correct this condition.

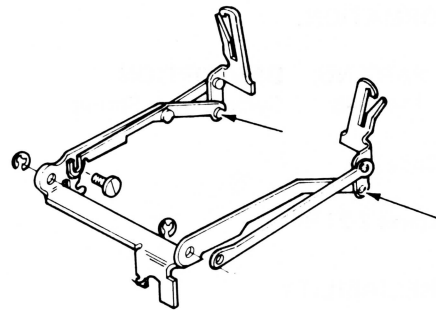
Figure 1

A number of machines were manufactured with defective fabric ribbon lift guide (13-37) rivets (Fig. 1). The rivet hardness and assembly method were changed to reduce breakage. If experiencing ribbon lift failures, check for either a loose or broken rivet and replace the lift guide assembly as necessary.

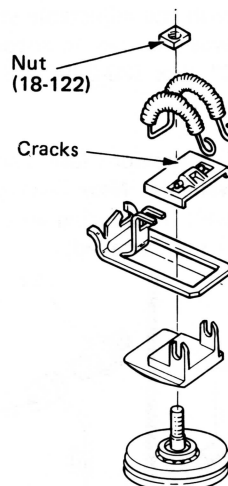
Figure 1

On the next service call check for cracks in the area indicated (Fig. 1). Also, examine the nut for two peen marks in the area of the pulley stud threads which are necessary to keep the nut tight. Replace the transport bracket assembly if cracks are found or the peen marks are missing.
